Time-domain IP and Resistivity Sections Measured at Four Landfills with Different Contents

V. Leroux* (LTH Lund University), T. Dahlin (LTH Lund University) & H. Rosqvist (NSR)

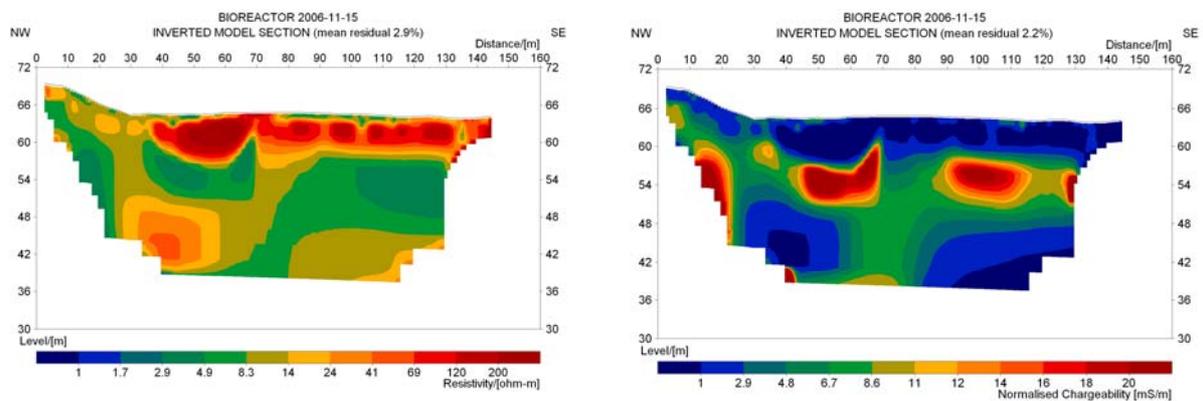
Figure 1 Resistivity (a) and normalized chargeability (b) at the bioreactor landfill.

A first thin and relatively conductive layer is observed on the resistivity section (Figure 1a) probably corresponding to the soil cover. Just below, a resistive layer with values over 70 Ω .m is visible, which is probably representative of drier, unsaturated waste material. 5 to 10 m below the ground surface the waste is saturated with water and exhibits much lower resistivity (below 40 Ω .m). Low resistivity is also observed on the left edge, outside the bioreactor. The saturated waste cannot be distinguished from its clayey bottom, neither from its clayey surroundings with resistivity. The normalized chargeability section (Figure 1b) shows relatively large values, above 15 mS/m, apparently confined to the saturated waste down to the expected bottom of the bioreactor at about 15 m depth. High chargeability is also visible on the left of the section, outside the bioreactor landfill, but still inside the waste management site.

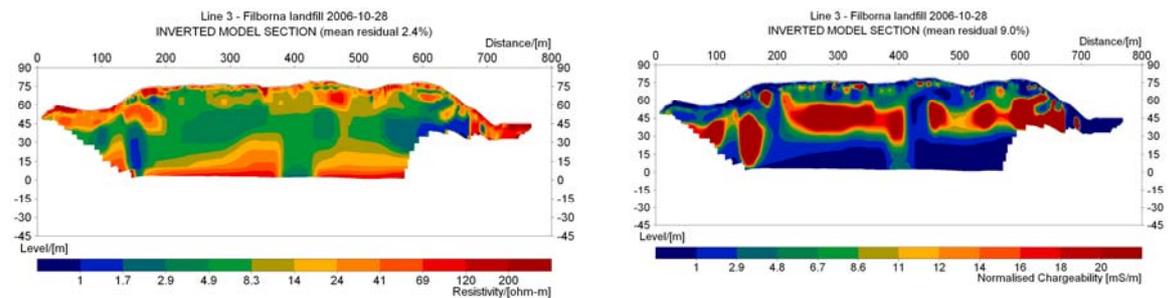
Figure 2 Resistivity (a) and normalized chargeability (b) at Filborna landfill.

On the inverted resistivity section shown in Figure 2a the discontinuous soil cover is apparent as a heterogeneous and globally resistive superficial layer. On the left hand-side of the landfill, inside the waste management site, a track of compacted inert soil materials appears with higher resistivity. On the right hand-side of the landfill the natural soil also appears with higher resistivity. Inside the landfill the resistivity decreases progressively and following an irregular pattern at depth probably reflecting different materials, increasing water content at depth, locally perched water tables and possibly variations in salinity. No clear transition is observed between the water saturated waste and glacial sediments which should occur at about 45 m above sea level, whereas the unweathered sandstone appears clearly as is expected around 15 m above sea level. The former bed of the diverted stream is apparent around $x=400$ m. Figure 2b shows small superficial polarisable bodies just below the soil cover. Extended areas with normalized chargeability above 16 mS/m are clearly visible in the saturated waste body, but also on the sides, below the track and below the slope on the right side. Large normalized chargeability is also observed at depth possibly corresponding to glacial sediments, but not in the fresh sandstone.

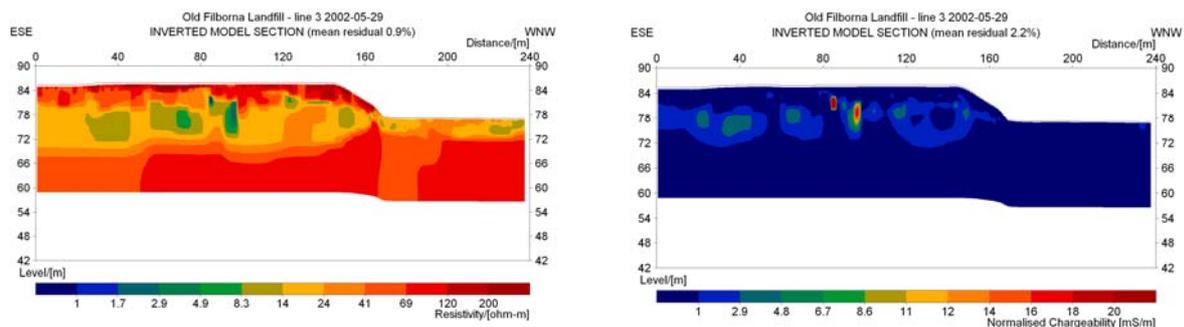
Figure 3 Resistivity (a) and normalized chargeability (b) at the old Filborna landfill.

Figure 3a shows higher resistivity in the heterogeneous soil cover on the landfill and also the most superficial waste materials. The underlying waste shows lower values (below 70 ohm.m) and comparable to the values observed in the natural clay tills on the right. These were saturated with water at the time of the measurements. The sandstone here too shows larger resistivity, but the low resistivity seems to extend below the waste in the natural geological materials below the landfill. The normalized chargeability section on Figure 3b shows no polarisability in the natural geological materials outside the landfill and much lower levels in the waste than at the two sites described above. Here too, high normalized chargeability seems to extend below the waste.

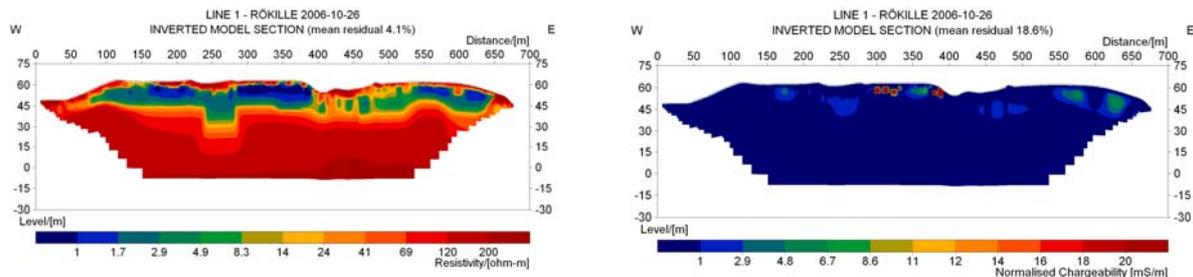
Figure 4 Resistivity (a) and normalized chargeability (b) at Rökille landfill.

On the inverted resistivity section (Figure 4a) the waste is clearly marked by lower resistivity (between 1 and 10 Ω .m) below the more resistive and heterogeneous cover. It is also clearly distinct from the underlying natural geological materials and the limit between low and high resistivity at depth seems to follow the original topography. However a fault or fracture zone is apparent around $x=250$ m and some contamination of the upper sediments is possible and signalled by lower resistivity. On Figure 4b polarisability appears restricted to the waste but with much lower levels than at the two first sites. Here too, it seems to extend below the waste.
